Smoke and Dye-Water Observation Summary

Western Run Pilot Project - Baltimore Maryland

STREET: FORDHAM DR. TEST 196 A 4	MAP #1: 1	MH: 1521076
CITY: BALTIMORE	MAP #2:	MH: 1521077
LOCALE: SMALL RESIDENTIAL STREET	TAPE #: JAM 1	TV'D LGTH: 58.15 ft
INSPECT REASON: OTHER	PIPE SIZE: 8 in	
SECTION TYPE: WASTEWATER	MATERIAL: VCP JT LGTH:	
AREA: 01-WR27	LINING: NO RELINING	
	RSRVD:

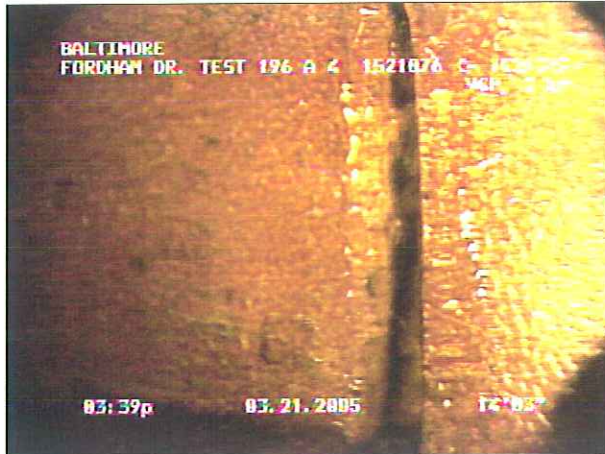
IMAGE: 25a, TAPE #: JAM 1, 00:29:49
14.29FT, Infiltration Running at joint at 02 o'clock TO 5 O'CLOCK

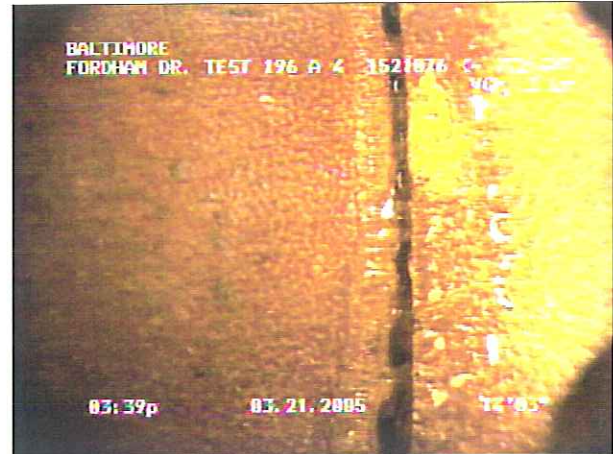
IMAGE: 25b, TAPE #: JAM 1, 00:29:49
14.29FT, Infiltration Running at joint at 02 o'clock TO 5 O'CLOCK

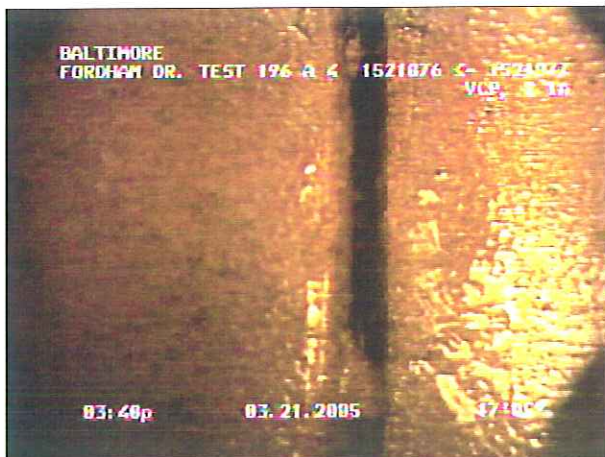
IMAGE: 26a, TAPE #: JAM 1, 00:30:52
17.41FT, Infiltration Running at joint at 03 o'clock

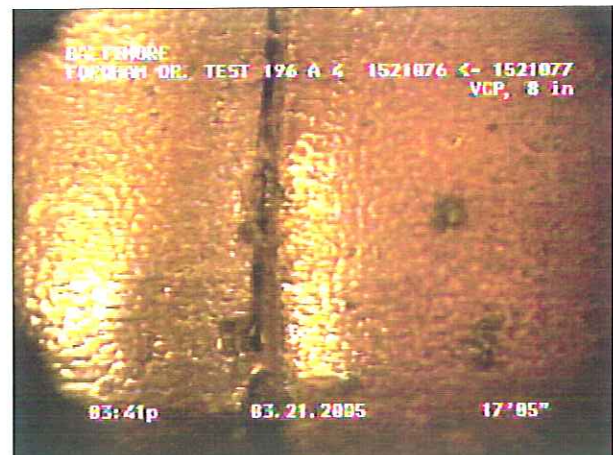
IMAGE: 27a, TAPE #: JAM 1, 00:30:52
17.41FT, Infiltration Seeping at joint at 09 o'clock

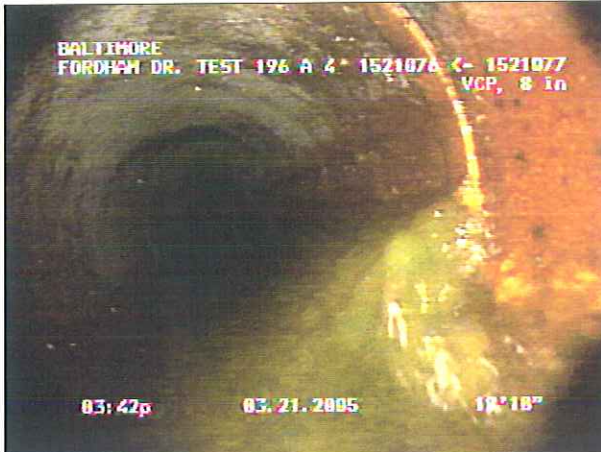
IMAGE: 28a, TAPE #: JAM 1, 00:31:19
19.82FT, Infiltration Gushing at joint at 04 o'clock

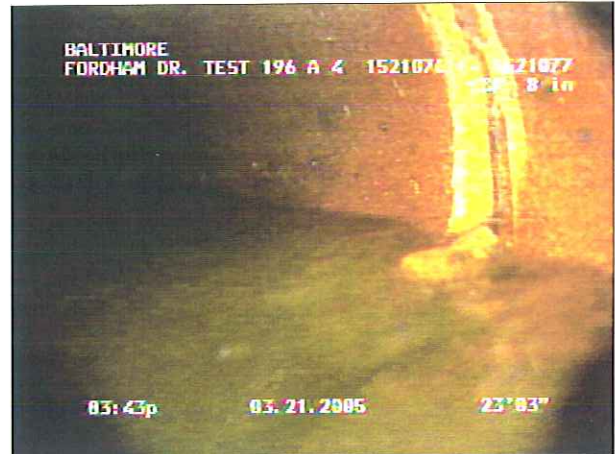
IMAGE: 29a, TAPE #: JAM 1, 00:31:55
23.24FT, Infiltration Running at joint at 04 o'clock

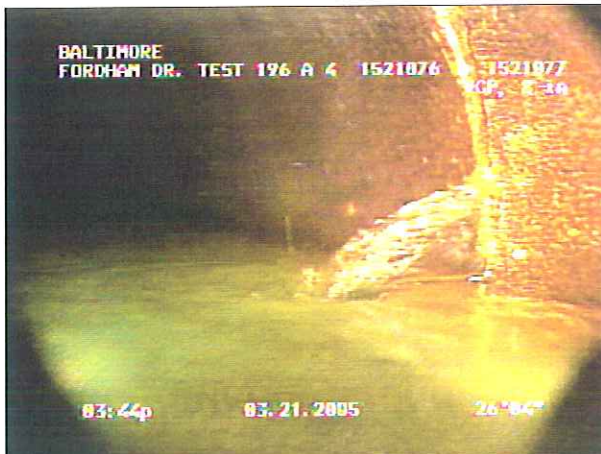
IMAGE: 30a, TAPE #: JAM 1, 00:32:28
26.36FT, Infiltration Gushing at joint at 03 o'clock

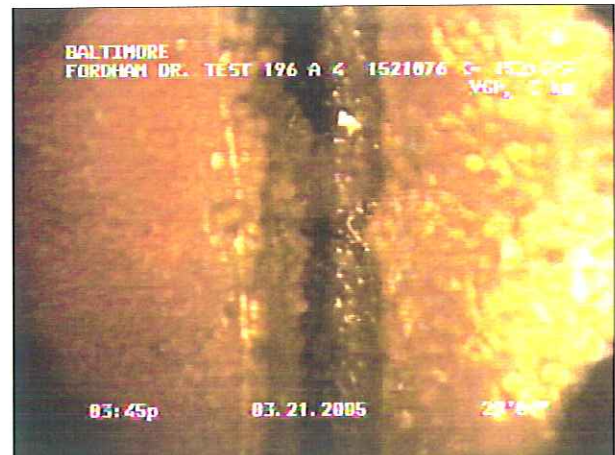
IMAGE: 31a, TAPE #: JAM 1, 00:33:13
29.78FT, Infiltration Running at joint at 03 o'clock

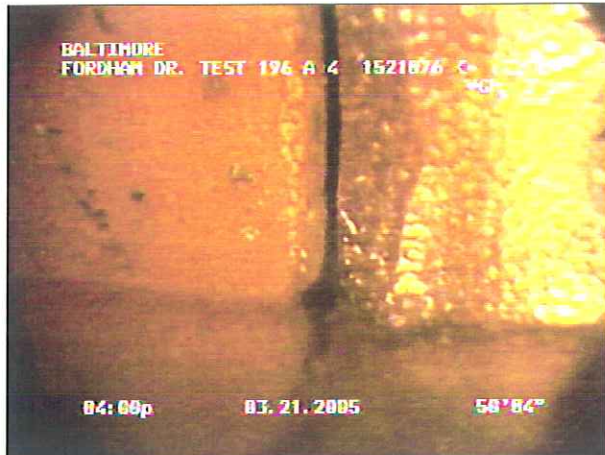
IMAGE: 33a, TAPE #: JAM 1, 00:36:27
50.31FT, Infiltration Running at joint at 03 o'clock

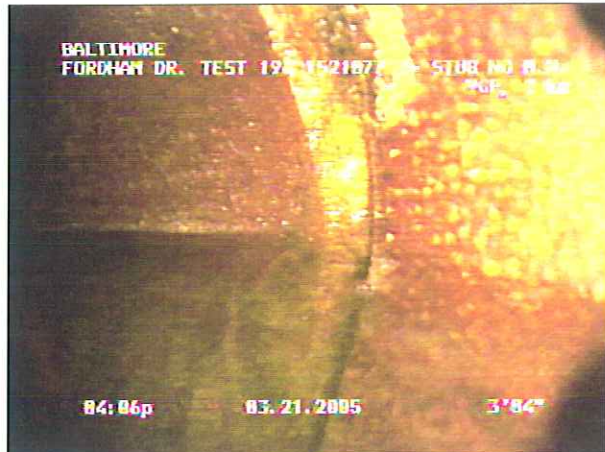
IMAGE: 36a, TAPE #: JAM 1, 00:38:34
3.32FT, Infiltration Running at joint at 04 o'clock

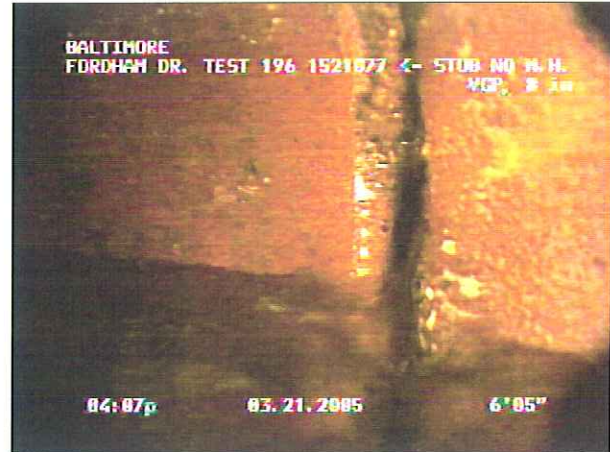
IMAGE: 37a, TAPE #: JAM 1, 00:39:30
6.44FT, Infiltration Running at joint at 04 o'clock

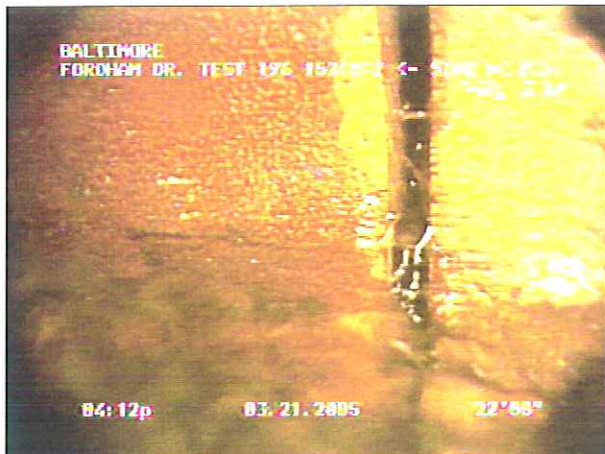
IMAGE: 38a, TAPE #: JAM 1, 00:42:57
22.03FT, Infiltration Running at joint at 04 o'clock

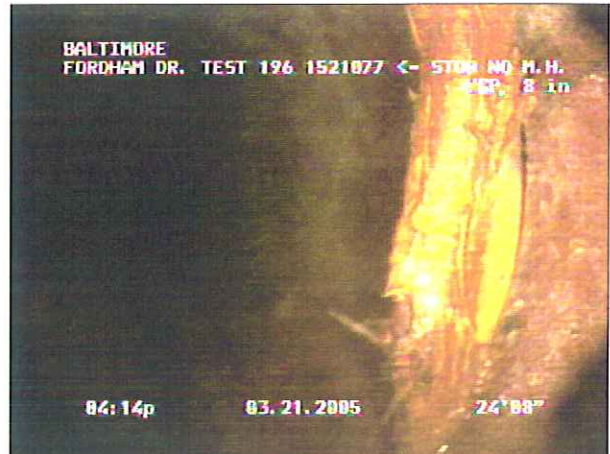
IMAGE: 39a, TAPE #: JAM 1, 00:43:32
24.65FT, gasket exposed, from 02 to 04 o'clock

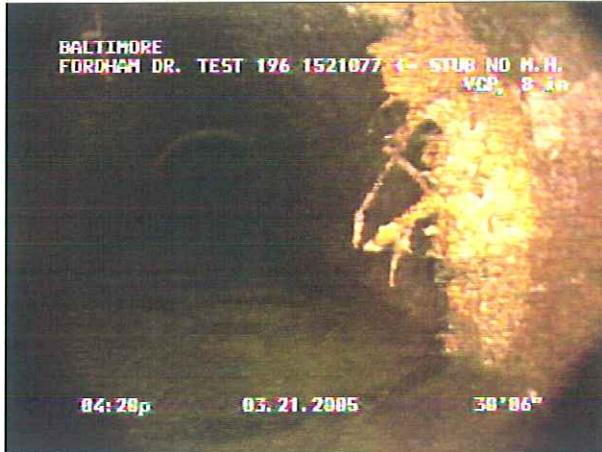
IMAGE: 40a, TAPE #: JAM 1, 00:44:32
30.49FT, roots light, from 01 to 04 o'clock

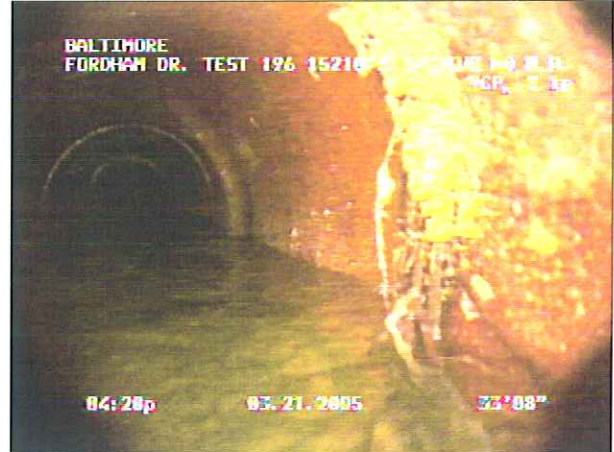
IMAGE: 41a, TAPE #: JAM 1, 00:44:59
33.71FT, roots light, from 01 to 04 o'clock

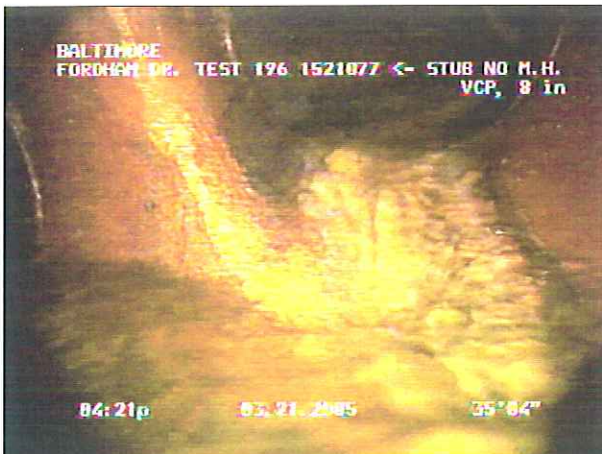
IMAGE: 42a, TAPE #: JAM 1, 00:45:35
35.31FT, service connection with infiltration running inside at 03 o'clock

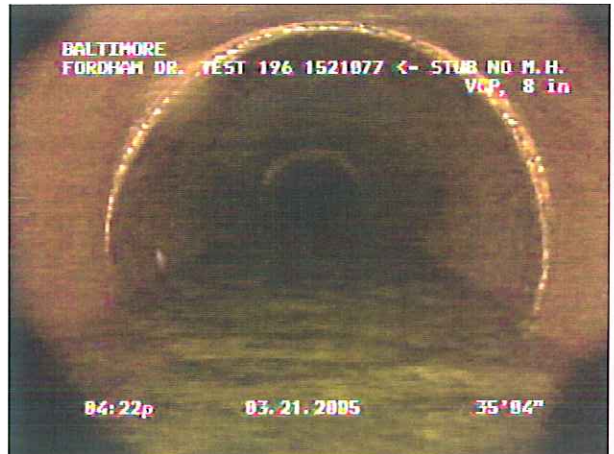
IMAGE: 43a, TAPE #: JAM 1, 00:45:58
35.92FT, Infiltration Seeping at joint at 03 o'clock

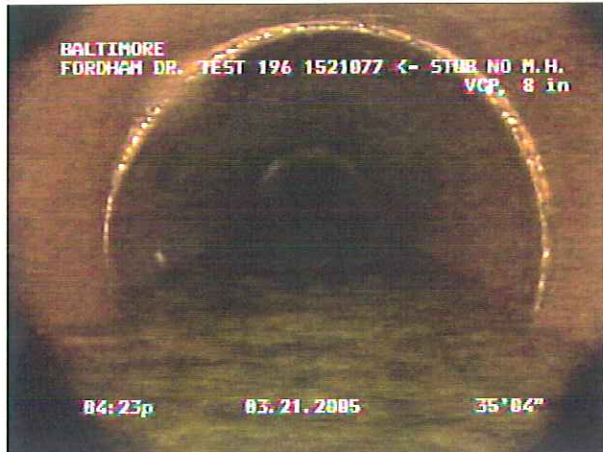
IMAGE: 44a, TAPE #: JAM 1, 00:45:58
35.92FT, Infiltration Seeping at joint at 11 o'clock

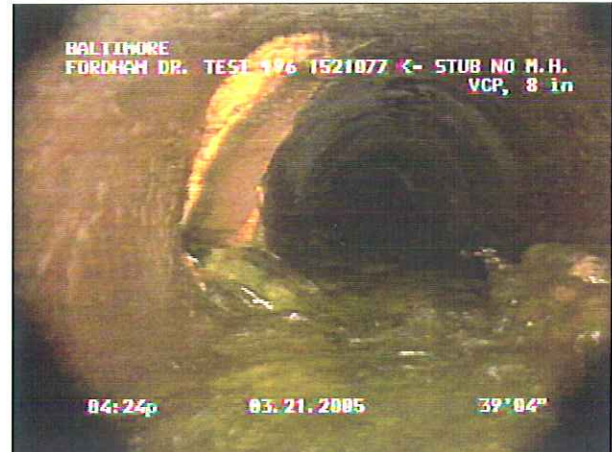
IMAGE: 45a, TAPE #: JAM 1, 00:46:57
40.45FT, break-in-connection with infiltration gushing inside at 10 o'clock

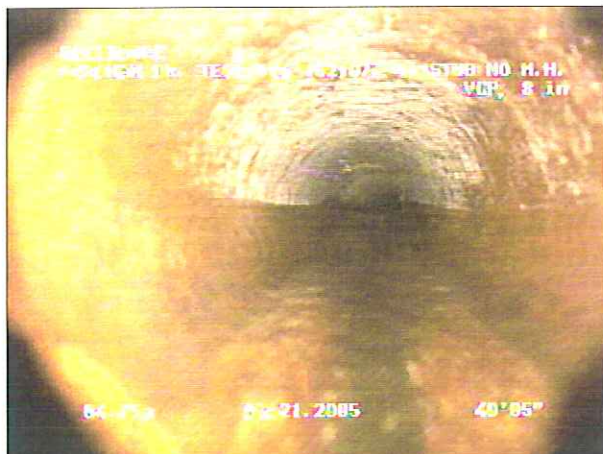
IMAGE: 46a, TAPE #: JAM 1, 00:47:34
40.45FT, break-in-connection with infiltration gushing inside at 10 o'clock

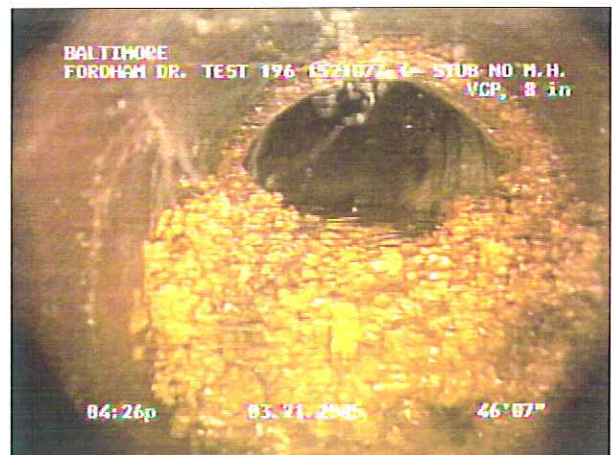
IMAGE: 47a, TAPE #: JAM 1, 00:48:31
46.58FT, service connection with infiltration running inside at 09 o'clock

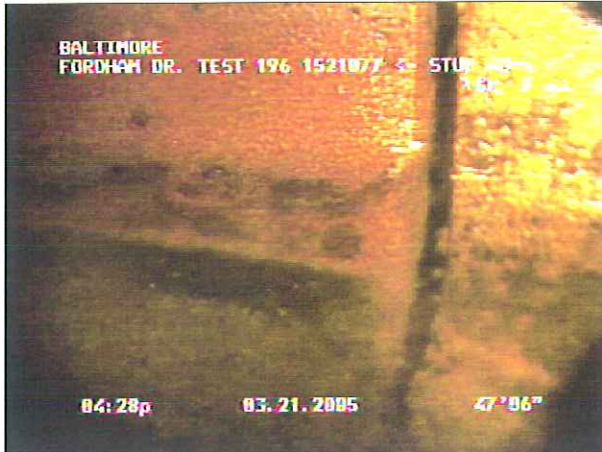
IMAGE: 48a, TAPE #: JAM 1, 00:48:55
47.49FT, Infiltration Running at joint at 04 o'clock

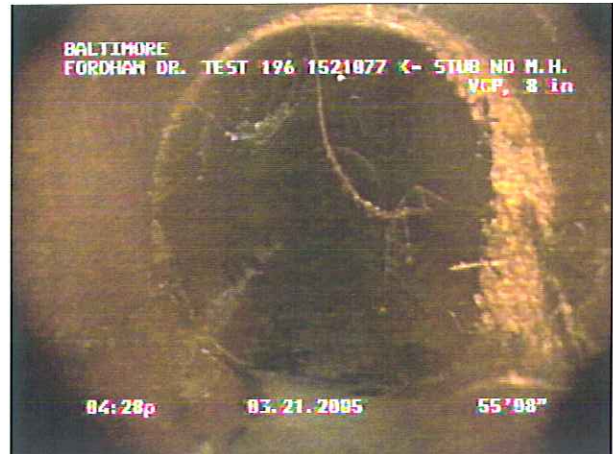
IMAGE: 49a, TAPE #: JAM 1, 00:49:29
55.64FT, roots medium, from 12 to 12 o'clock

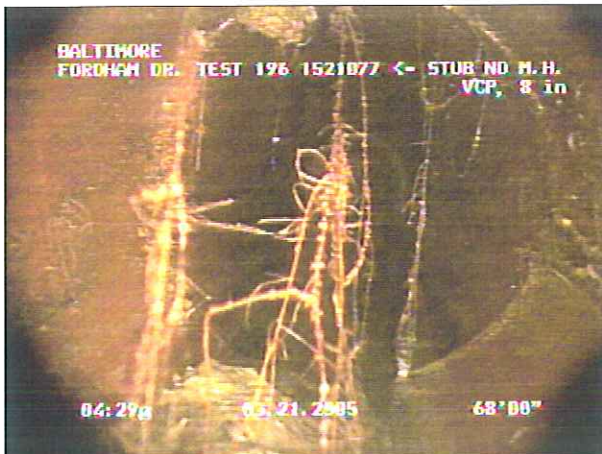
IMAGE: 50a, TAPE #: JAM 1, 00:50:13
68.01FT, roots medium, from 12 to 12 o'clock, START

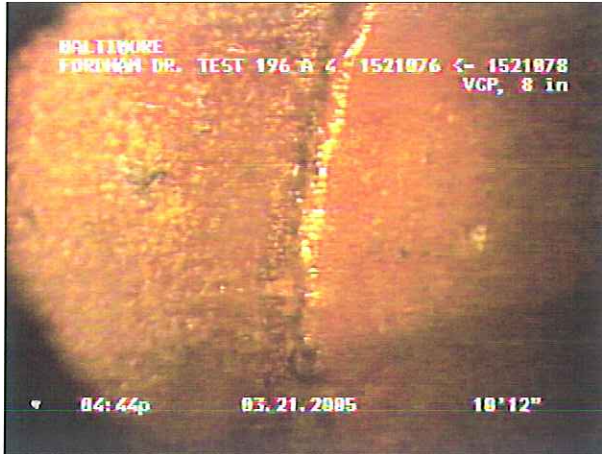
IMAGE: 55a, TAPE #: JAM 1, 00:54:00
10.97FT, Infiltration Running at joint at 09 o'clock

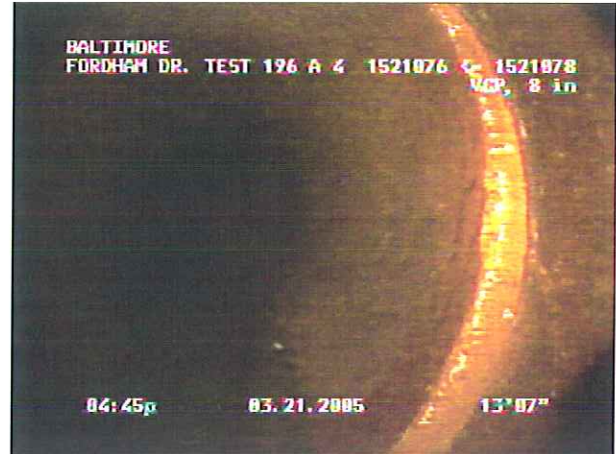
IMAGE: 56a, TAPE #: JAM 1, 00:54:23
13.78FT, Infiltration Running at joint at 02 o'clock

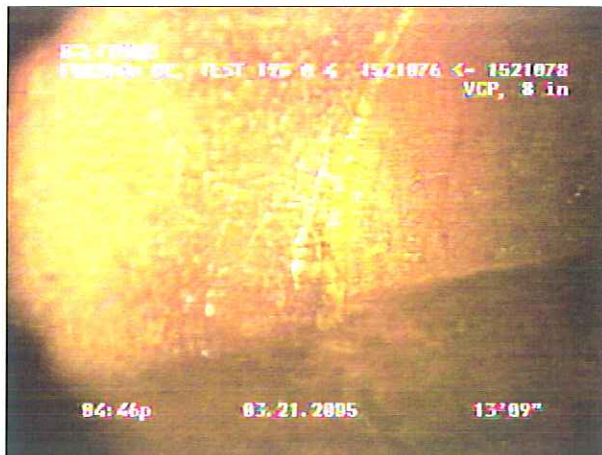
IMAGE: 57a, TAPE #: JAM 1, 00:54:40
13.78FT, Infiltration Running at joint at 09 o'clock

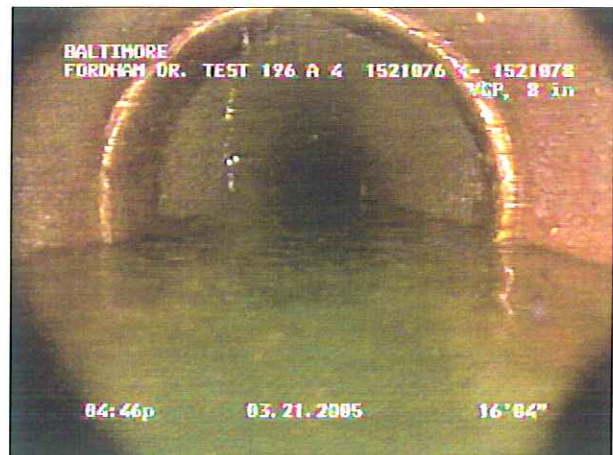
IMAGE: 58a, TAPE #: JAM 1, 00:55:03
16.3FT, Infiltration Running at joint at 12 o'clock to 12 o'clock

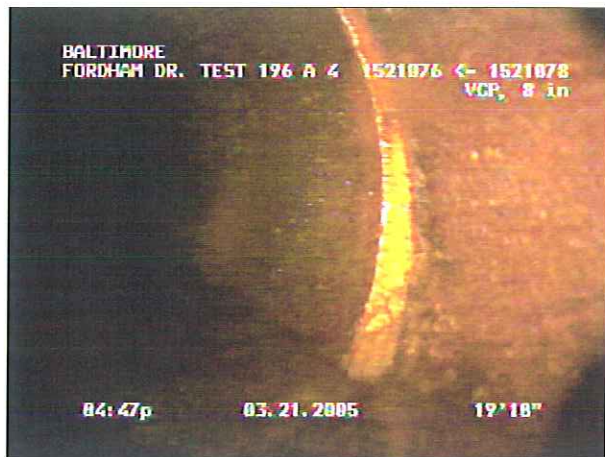
IMAGE: 59a, TAPE #: JAM 1, 00:55:26
19.82FT, Infiltration Running at joint at 03 o'clock

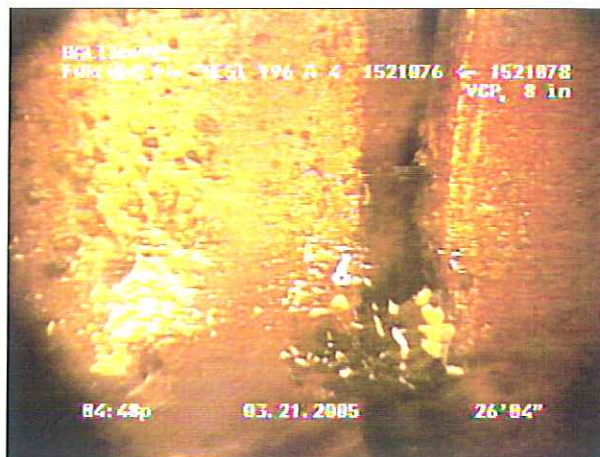
IMAGE: 60a, TAPE #: JAM 1, 00:56:16
26.36FT, Infiltration Running at joint at 09 o'clock

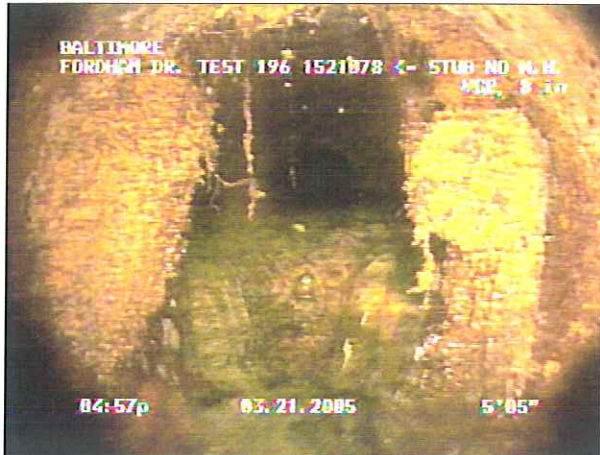
IMAGE: 65a, TAPE #: JAM 1, 01:00:36
5.43FT, roots heavy, from 12 to 12 o'clock, START

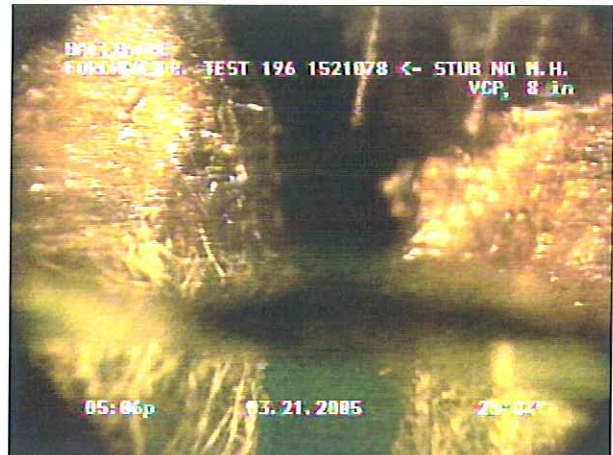
IMAGE: 66a, TAPE #: JAM 1, 01:07:07
25.35FT, camera blocked, inspection abandoned, HEAVY ROOTS
